An Inspection of:

2710 E. Clydesdale Trail

Property Inspected: 2710 E. Clydesdale Trail, Phoenix, AZ. 85032

Date: 1-15-08 Time: 9:00 a.m. Condo Single Family Town Home Multi- Plex

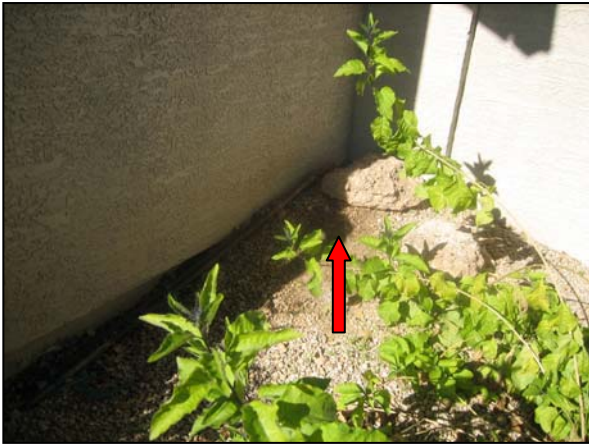
2. The grade at the n.e. exterior is above the finished floor. This can allow moisture to wick into the walls. Grade should be lowered leaving approx. 4" -6" of exposed stem wall.

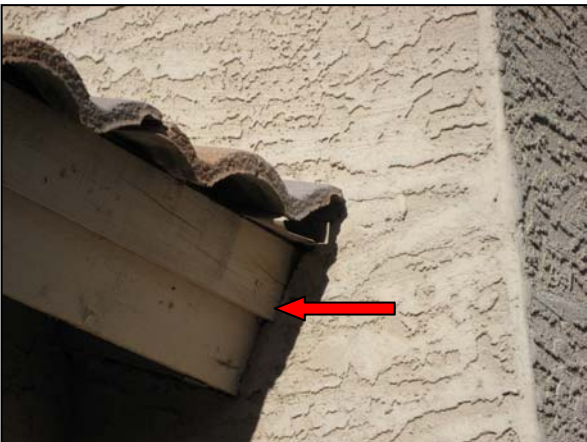
3. Seal the roof to wall connection at the chimney.

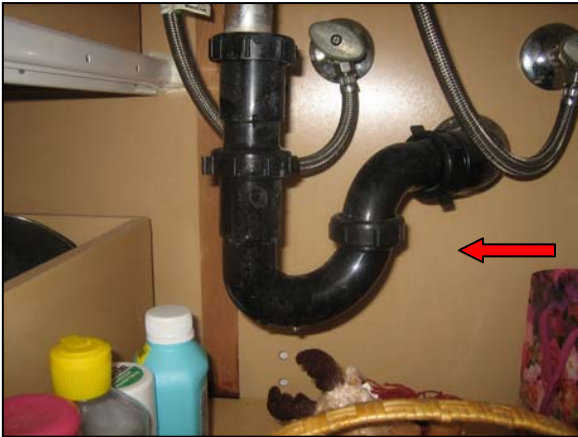
- 7. Thermal imaging revealed evidence of moisture in the wall behind the hall bath sink. This is a possible drain leak. Consult a qualified contractor.

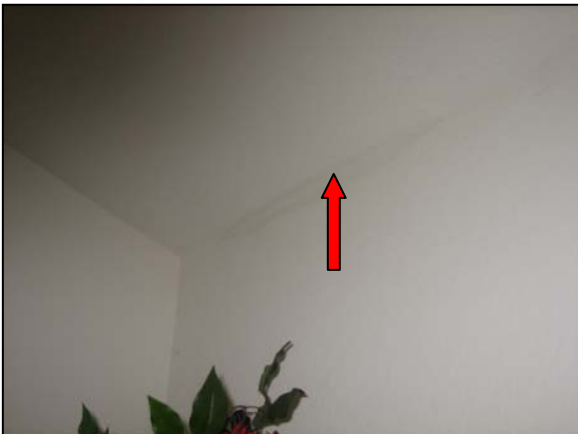
- 8. The den doors have settled and stick/rub in the opening.
- 9. The master bedroom single hung window has a defective balancer. The window does not stay open.
- 10. There is evidence of a roof leak at the family room ceiling. There is a small water stain at the intersection of the wall and ceiling. Thermal imaging revealed an area approx. two foot square of elevated moisture. This area corresponds to the patio and main roof connections. Consult a qualified contractor.

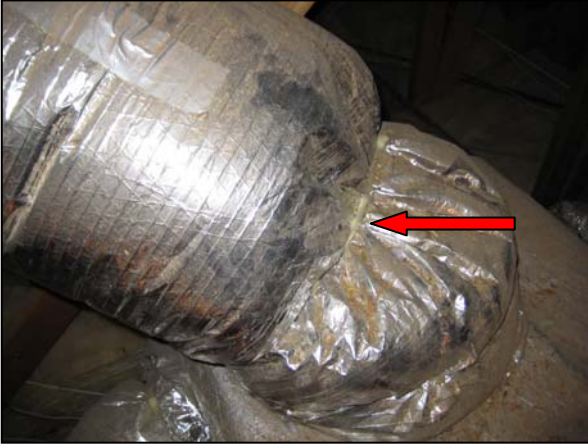
12. There is a section of duct, coming from the air handler, that is kinked/restricted by a zip tie. Consult a qualified contractor.
